# ISBN: 978-93-94687-30-1 Soil Erosion Status, Priority Treatment Areas and Conservation Measures for Different Districts of Goa

ICAR-Indian Institute of Soil and Water Conservation 218, Kaulagarh Road, Dehradun-248 195, Uttarakhand

ICAR-Central Coastal Agricultural Research Institute Ela, Old Goa-403 402, Goa

# Soil Erosion Status, Priority Treatment Areas and Conservation Measures for Different Districts of Goa

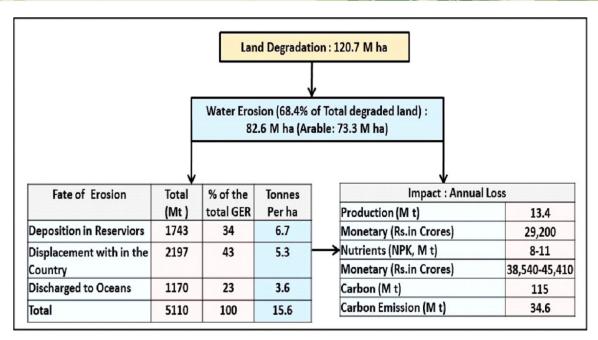
Fig. 2.1. Soil erosion and associated losses in India (GER- Gross erosion rate)

- **1.1. Land Degradation:** In India, about 120.7 million ha area, which includes arable and non-arable lands, is subjected to various forms of land degradation (Maji et al., 2010), with maximum (82.6 million ha, 68.4%) contribution by water erosion (49% area accounts for soil loss >10.0 t ha<sup>-1</sup> yr<sup>-1</sup>). The soil erosion and other associated losses are presented in (Fig.2.1).

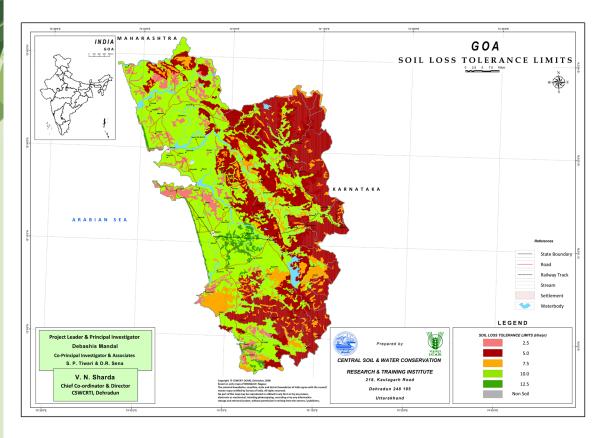
Fig. 4.1: Soil Loss Tolerance Limit map for erosion control in Goa state

The soil loss tolerance limit (T) values for Goa varied between 2.5 and 12.5 Mg ha<sup>-1</sup> yr<sup>-1</sup>, indicating a high degree of soil heterogeneity with respect to soil depth, infiltration, bulk density, organic matter content, erodibility and pH within the same physiographic region. The area under different soil loss tolerance limit classes is presented in (Table 4.2.) Almost 43% area in the state has a T-value of >10 t ha<sup>-1</sup> yr<sup>-1</sup> followed by 36% area with a T-value of 5 t ha<sup>-1</sup> yr<sup>-1</sup>. In North Goa Districts, Talukas like Satari, parts of Bicholim, Ponda has a T-value of 5 t ha<sup>-1</sup> yr<sup>-1</sup> which is of great concern; while in South Goa District Taluka like Dharbandora, Sanguem, parts of Canacona has similar T-values. Near the coast line the Mormugao Taluka in South Goa District and Pernem Taluka in North Goa District has a very low T-value of 2.5 t ha<sup>-1</sup> yr<sup>-1</sup>. In general the inland areas have lower T-values and the coastal areas have a higher T-value as evident from (Fig 4.1.)

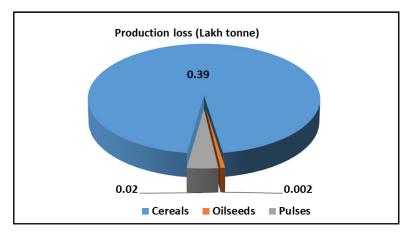
Fig. 4.3. Estimated total monetary loss of rainfed crops due to soil erosion in Goa State

The productivity losses of cereal and millets, oilseed and pulse crops were estimated to be 1089 kg ha<sup>-1</sup>, 599 kg ha<sup>-1</sup> and 212 kg ha<sup>-1</sup>, respectively. The average productivity loss of all these crops together is 927 kg ha<sup>-1</sup> (Sharda and Dogra, 2013), which in monetary terms was ₹17,833 ha<sup>-1</sup> during 2018-19 (Fig. 4.3). The Gross State Domestic Product (GSDP) of Goa for 2018-19 at current prices was estimated to be ₹77,172 crore at price of 2019. Therefore, the State's loss due to soil erosion by rain water during the cultivation of rainfed cereal, oilseed and pulse crops is equal to 0.10% of its GSDP during 2018-19.

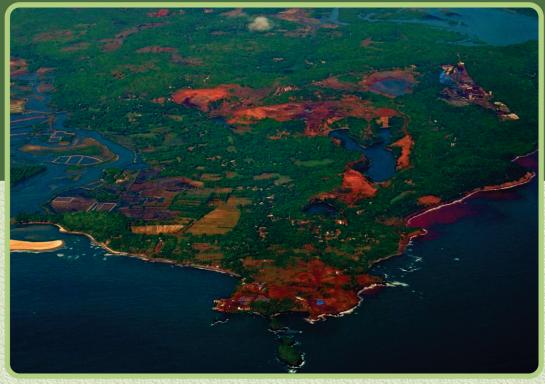
Areal photograph of Goa state showing the land degradation due to mining
